CORRECTIVE ACTION STABILIZATION QUESTIONNAIRE

Refined Metals Corp.IND 000 718 130Beech Grove, INModerate

VISUAL SITE INSPECTION
REFINED METALS CORPORATION
IND 000718130

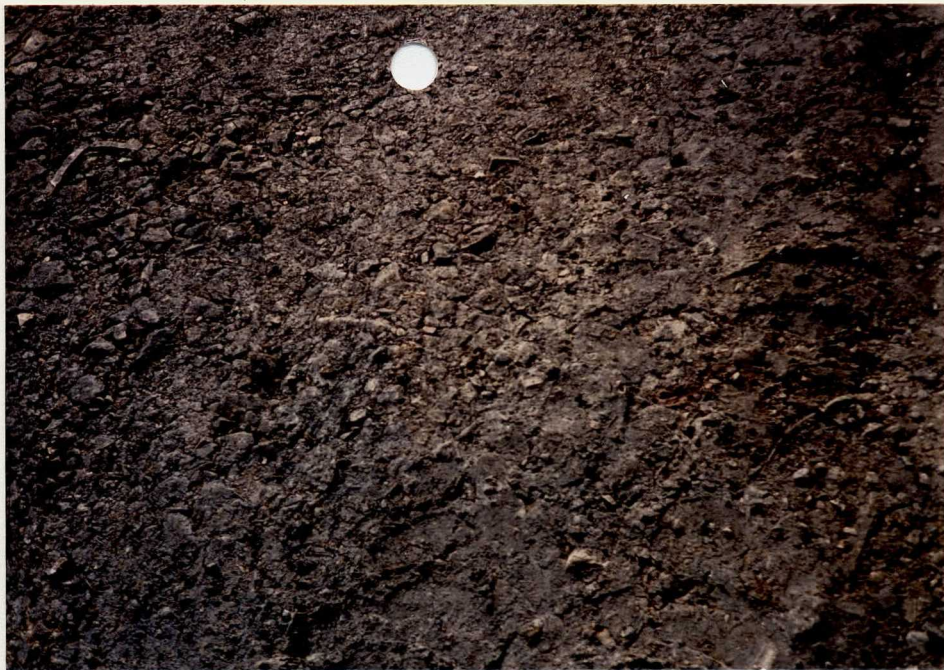
In the northeast corner of the property, pieces of broken batteries were noted buried in the soil and a reddish coloration was observed in spots in the soil (photograph 1).

PROJECT/CASE NO: Refined Metals
 SUBJECT: discoloration in soil
 LOCATION: east side
 CITY: _____ COUNTY: _____ STATE: _____
 DATE: _____ TIME: _____
 WEATHER: (SUN) (HAZE) (CLOUDY) (RAIN) (SNOW)
 PHOTOGRAPHER (Sig.) _____
 WITNESS: _____
 CAMERA: _____
 FILM TYPE: _____ ASA: _____ T.I.: _____ f: _____
 NEGATIVE LOCATION: _____ FILE #: _____
 PROCESSED BY: _____
 PHOTO #: _____ of _____

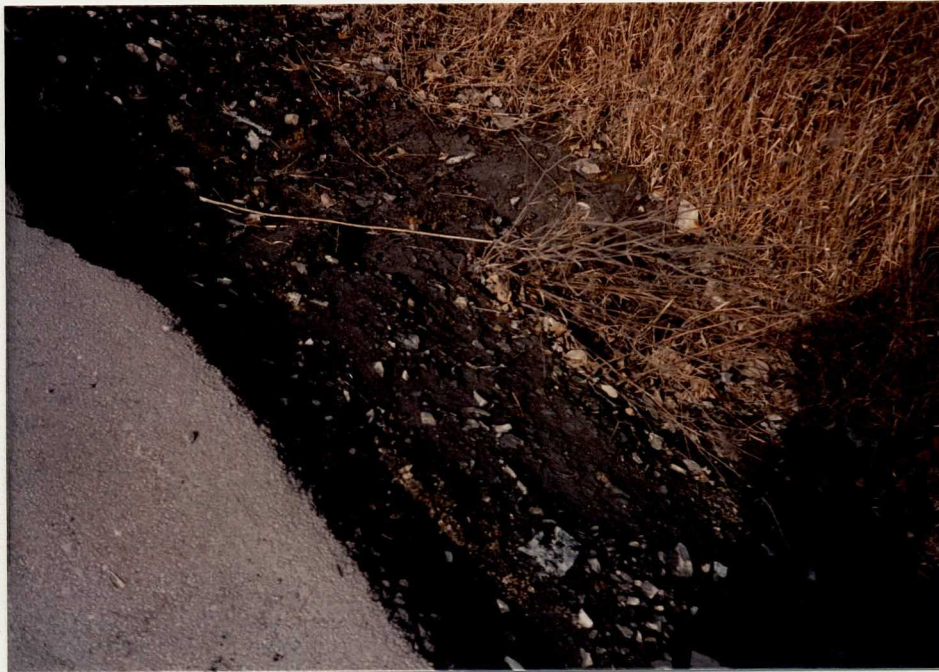
The general appearance of this facility indicates poor housekeeping practices. Large portions of the property were gray from lead dust. Gray puddles were observed on the north and west sides of the facility; as well as a gray layer covering the soil. When the top layer of soil was scraped away, a more typical soil color was revealed.

PROJECT/CASE NO: Refined Metals
 SUBJECT: gray color of soil
 LOCATION: North perimeter
 CITY: _____ COUNTY: _____ STATE: _____
 DATE: 2/24/87 TIME: _____
 WEATHER: (SUN) (HAZE) (CLOUDY) (RAIN) (SNOW)
 PHOTOGRAPHER (Sig.) Judy Kleiman
 WITNESS: Dave Koeppe, IDEM
 CAMERA: _____
 FILM TYPE: 35mm ASA 100 T.I.: _____ f: _____
 NEGATIVE LOCATION: _____ FILE #: _____
 PROCESSED BY: _____
 PHOTO #: _____ of _____

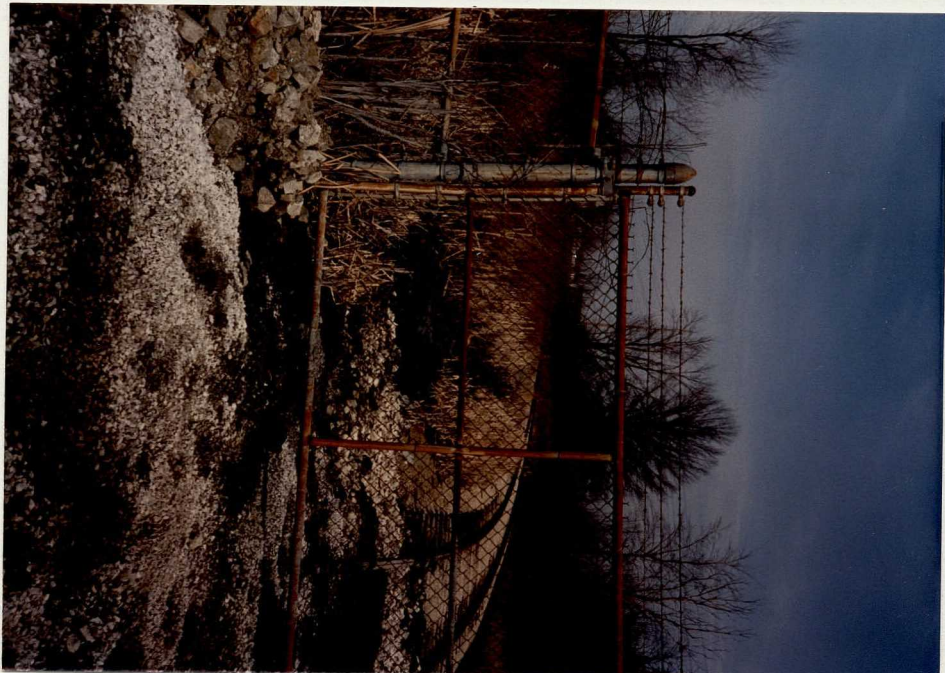
PROJECT/CASE NO: Refined Metals
 SUBJECT: drainage ditch, gray soil
 LOCATION: North side
 CITY: _____ COUNTY: _____ STATE: _____
 DATE: 2/24/87 TIME: _____
 WEATHER: (SUN) (HAZE) (CLOUDY) (RAIN) (SNOW)
 PHOTOGRAPHER (Sig.) _____
 WITNESS: Dave Koeppe, IDEM
 CAMERA: _____
 FILM TYPE: _____ ASA: _____ T.I.: _____ f: _____
 NEGATIVE LOCATION: _____ FILE #: _____
 PROCESSED BY: _____
 PHOTO #: _____ of _____

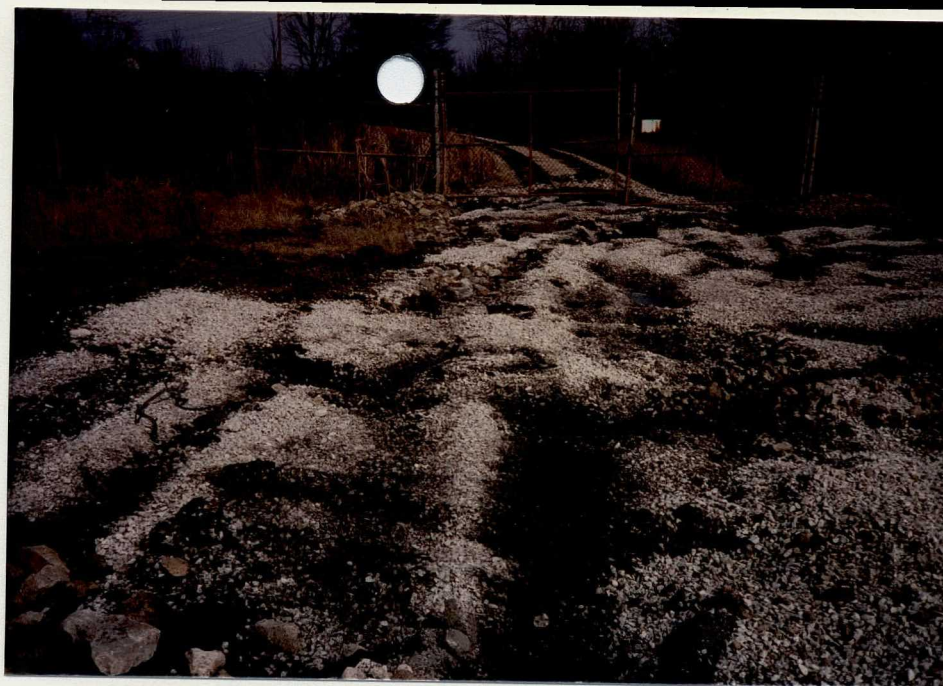
PROJECT/CASE NO: Refined Metals
SUBJECT: drainage ditch, gray soil
LOCATION: North side

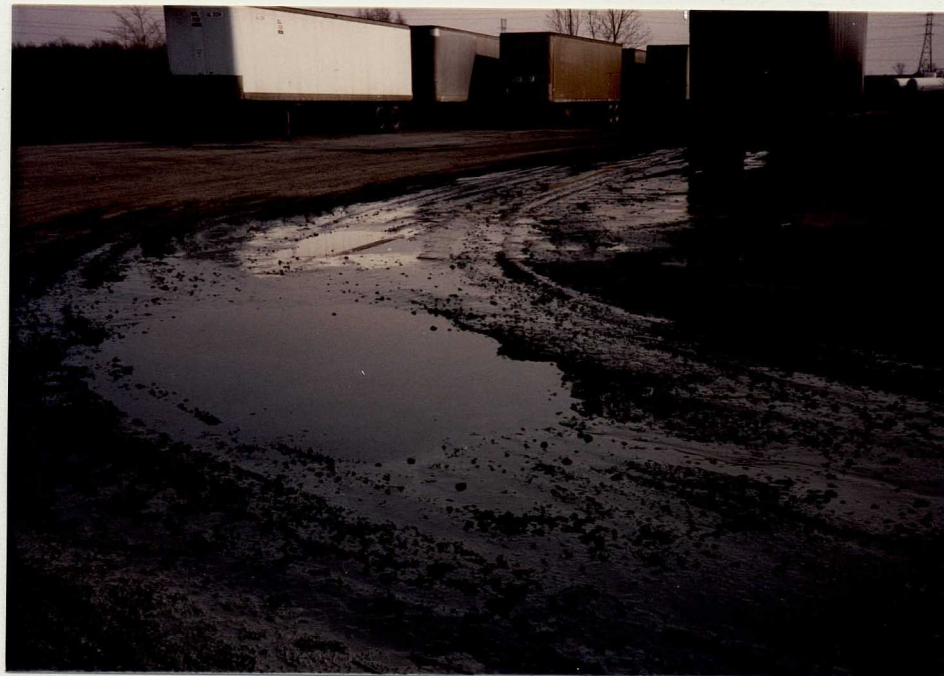
Several gray puddles were observed in the area around the breaker building. Photographs 5 and 6 show some of these gray puddles.

PROJECT/CASE NO: Refined Metals
SUBJECT: gray puddles
LOCATION: NW side

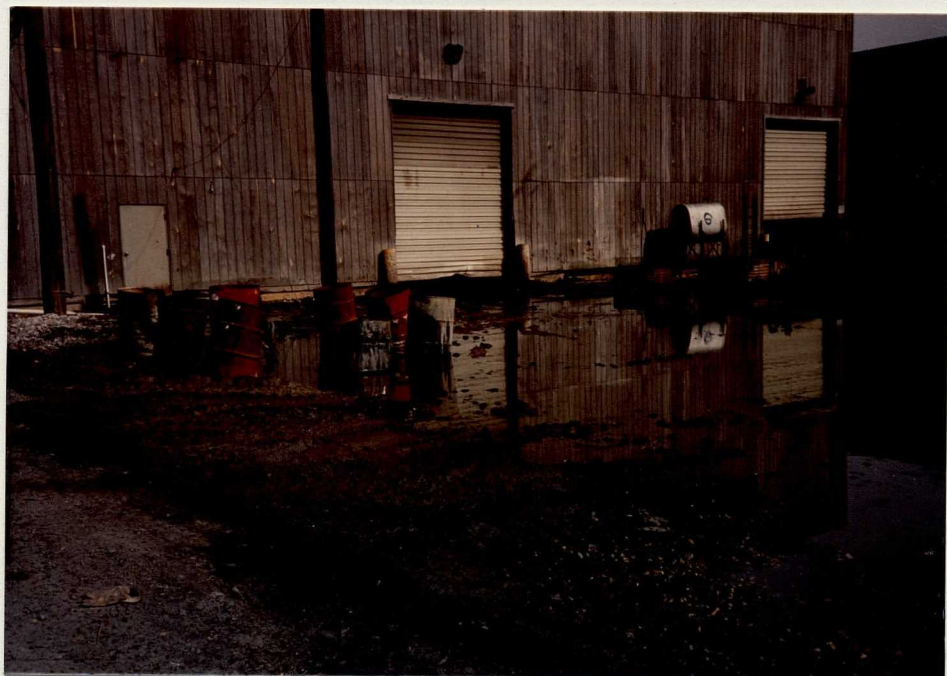
PROJECT/CASE NO: Refined Metals
SUBJECT: gray puddles
LOCATION: breakers building

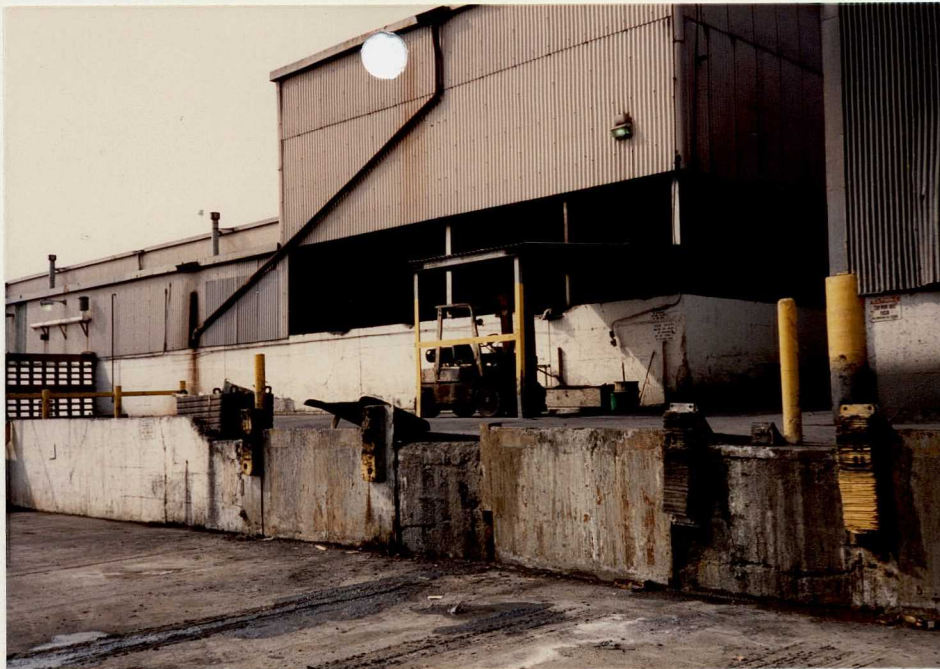
(7)

PROJECT/CASE NO: Refined Metals
SUBJECT: unloading dock
LOCATION: east side
CITY: _____ COUNTY: _____ STATE: _____
DATE: _____ TIME: _____
WEATHER: (SUN) (HAZE) (CLOUDY) (RAIN) (SNOW)
PHOTOGRAPHER (Sig.) Judy Kleiman
WITNESS: _____
CAMERA: _____
FILM TYPE: _____ ASA: _____ T.1/ _____ f. _____
NEGATIVE LOCATION: _____ FILE #: _____
PROCESSED BY: _____
PHOTO #: _____ of _____

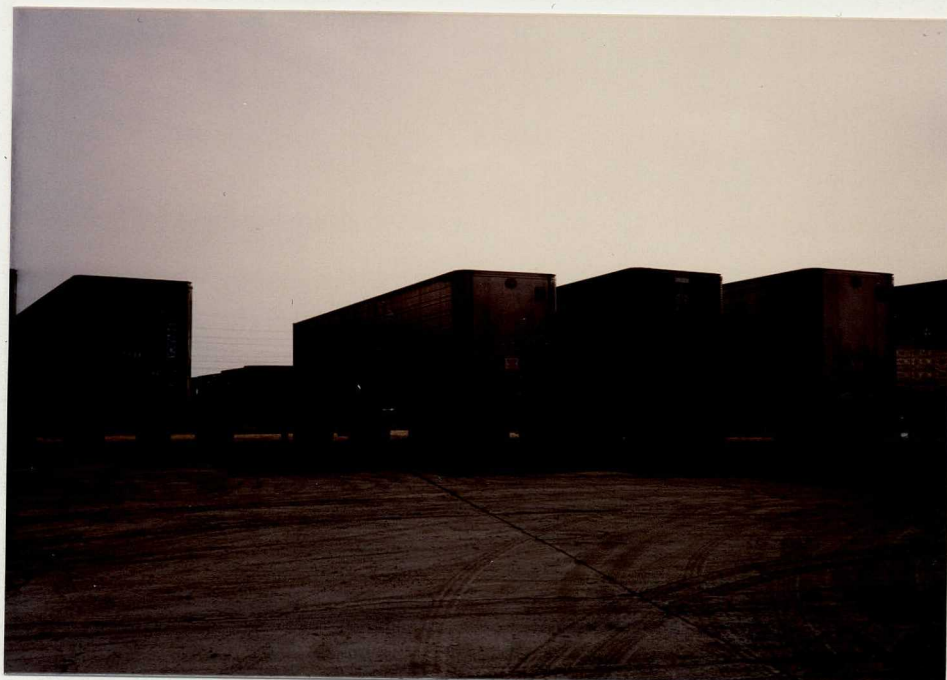
(8)

PROJECT/CASE NO: Refined Metals
SUBJECT: Storage Trailers
LOCATION: east side
CITY: _____ COUNTY: _____ STATE: _____
DATE: _____ TIME: _____
WEATHER: (SUN) (HAZE) (CLOUDY) (RAIN) (SNOW)
PHOTOGRAPHER (Sig.) Judy Kleiman
WITNESS: _____
CAMERA: _____
FILM TYPE: _____ ASA: _____ T.1/ _____ f. _____
NEGATIVE LOCATION: _____ FILE #: _____
PROCESSED BY: _____
PHOTO #: _____ of _____

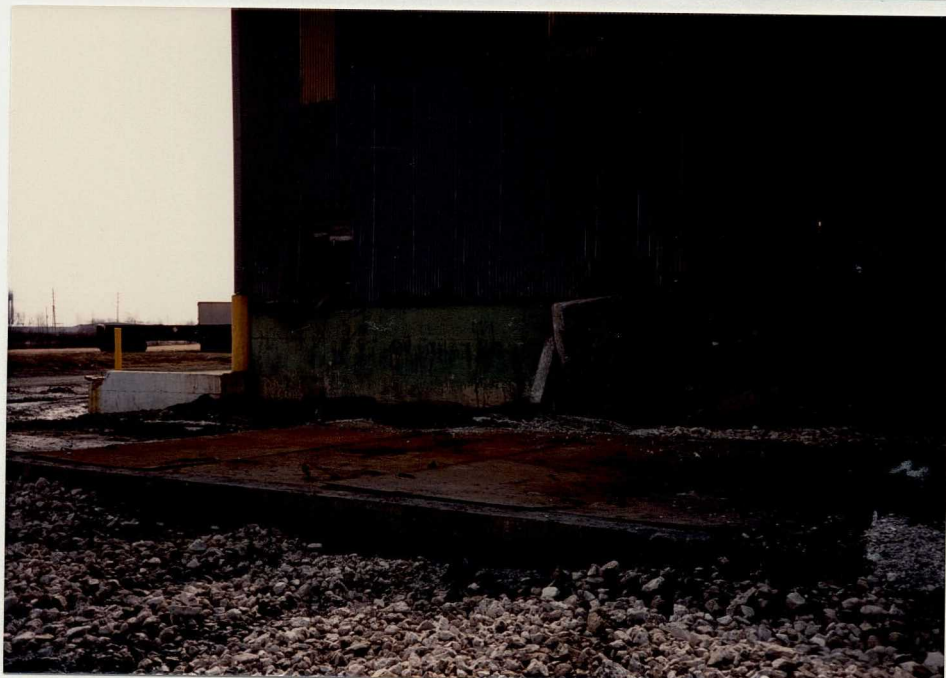
(9)

On the driveway, north of the building, was a area where trucks unloaded already broken batteries. There is a sump here covered with steel plates (photograph 9). This sump is to catch run-off from the materials building, where water is used for dust control. The solids settle out here in the sump and are then combined with the battery plates in the blast furnace.

PROJECT/CASE NO: Refined Metals
SUBJECT: Sump
LOCATION: various side
CITY: _____ COUNTY: _____ STATE: _____
DATE: _____ TIME: _____
WEATHER: (SUN) (HAZE) (CLOUDY) (RAIN) (SNOW)
PHOTOGRAPHER (Sig.) _____
WITNESS: _____
CAMERA: _____
FILM TYPE: _____ ASA: _____ T.1/ _____ f. _____
NEGATIVE LOCATION: _____ FILE #: _____
PROCESSED BY: _____
PHOTO #: _____ of _____

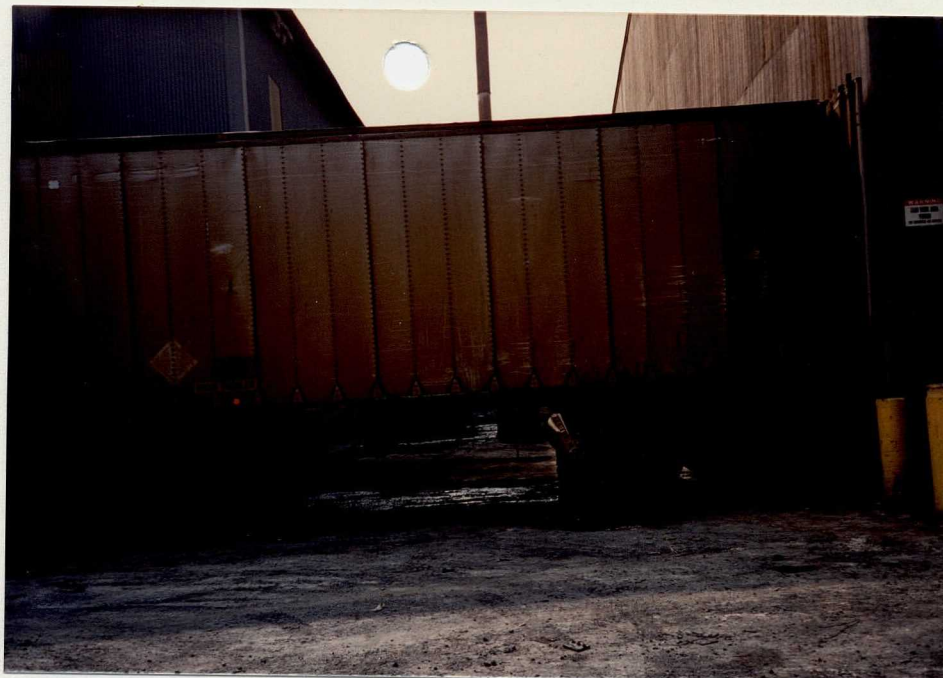
(10)

The unbroken batteries received are unloaded directly into the breaker building. Photograph 10 shows a truck backed up to this building to unload the batteries. A stream of liquid which could have been sulfuric acid was observed dripping from the truck. A large battery breaker inside the building was receiving the batteries and crushing them. Photograph 11 shows the battery breaker inside the breaker building. Sulfuric acid was observed dripping out below from the battery breaker.

PROJECT/CASE NO: Refined Metals
SUBJECT: Trucks unloading to breaker bldg.
LOCATION: _____
CITY: _____ COUNTY: _____ STATE: _____
DATE 2/24/87 TIME _____
WEATHER: (SUN) (HAZE) (CLOUDY) (RAIN) (SNOW)
PHOTOGRAPHER (Sig.) _____
WITNESS: _____
CAMERA: _____
FILM TYPE _____ ASA _____ T.1/ _____ f. _____
NEGATIVE LOCATION: _____ FILE #: _____
PROCESSED BY: _____
PHOTO #: _____ of _____

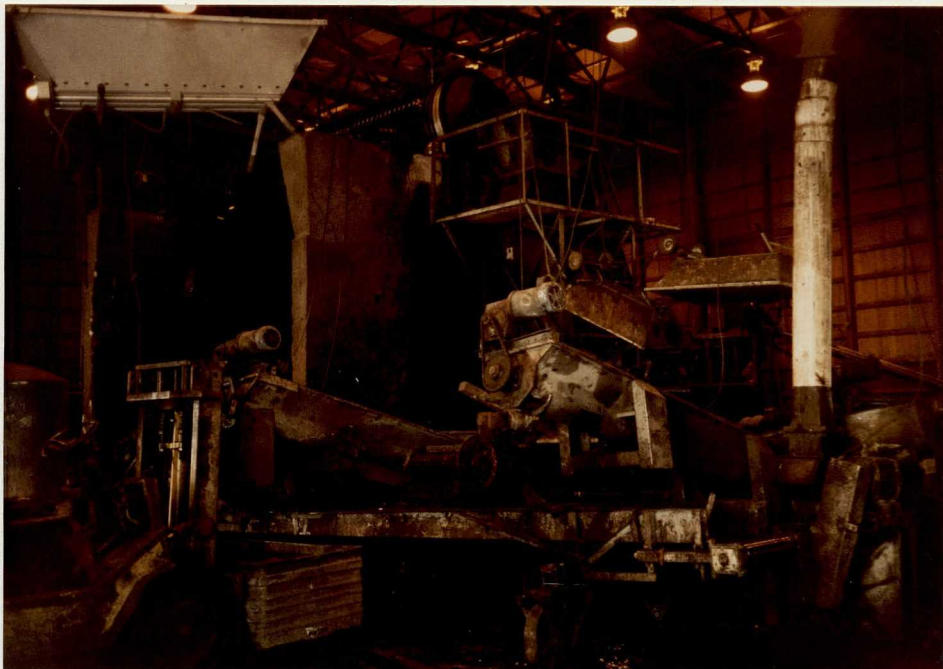
(11)

PROJECT/CASE NO: Refined Metals
SUBJECT: Breaker building, Battery
LOCATION: Breaker
CITY: _____ COUNTY: _____ STATE: _____
DATE 2/24/87 TIME _____
WEATHER: (SUN) (HAZE) (CLOUDY) (RAIN) (SNOW)
PHOTOGRAPHER (Sig.) _____
WITNESS: _____
CAMERA: _____
FILM TYPE _____ ASA _____ T.1/ _____ f. _____
NEGATIVE LOCATION: _____ FILE #: _____
PROCESSED BY: _____
PHOTO #: _____ of _____

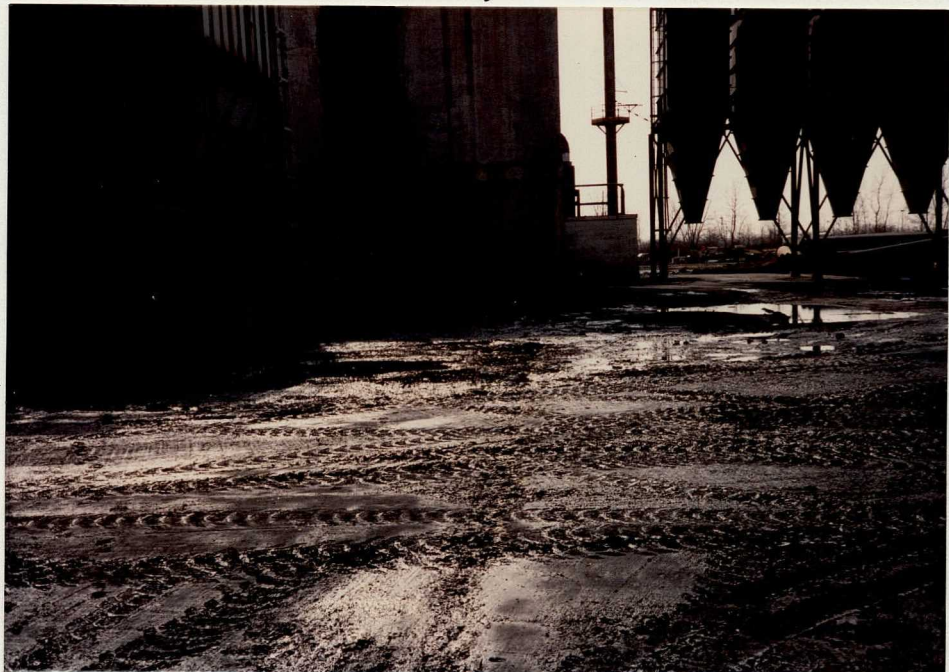
(12)

Three baghouses are located on the west side of the building (photograph 12). A new baghouse is under construction here (photograph 13). It is likely that the gray layer covering the soil on this property is the result of a leak in the baghouse operations.

These units are strongly suspected of leaks in the past. State reports release to the air on 11/8/82 due to faulty air pollution control equipment. Also reports of air release on March & April of 1982. Considerable soil contamination is believed to have resulted from leaks in baghouse.

PROJECT/CASE NO: Refined Metals
SUBJECT: Bag House
LOCATION: west side
CITY: _____ COUNTY: _____ STATE: _____
DATE 2/24/87 TIME _____
WEATHER: (SUN) (HAZE) (CLOUDY) (RAIN) (SNOW)
PHOTOGRAPHER (Sig.) Judy Helmer
WITNESS: _____
CAMERA: _____
FILM TYPE _____ ASA _____ T.1/ _____ f. _____
NEGATIVE LOCATION: _____ FILE #: _____
PROCESSED BY: _____
PHOTO #: _____ of _____

This facility requires further investigation to determine the full nature and extent of contamination. This should include analysis of deep soil cores and the installation of wells to assess the condition of the ground-water. Sampling by IDEM in November 1985 has indicated lead in all samples, but no plan for corrective action has been yet been developed.

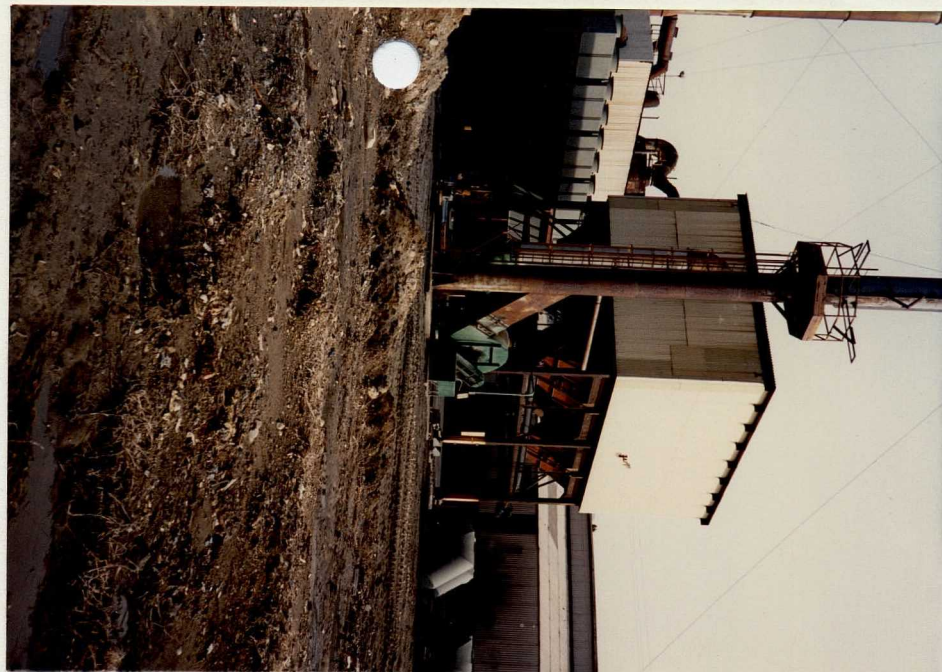
(13)

PROJECT/CASE NO: Refined Metals
SUBJECT: new baghouse
LOCATION: _____
CITY: _____ COUNTY: _____ STATE: _____
DATE: _____ TIME: _____
WEATHER: (SUN) (HAZE) (CLOUDY) (RAIN) (SNOW)
PHOTOGRAPHER (Sig.) _____
WITNESS: _____
CAMERA: _____
FILM TYPE: _____ ASA: _____ T.I.: _____ f: _____
NEGATIVE LOCATION: _____ FILE #: _____
PROCESSED BY: _____
PHOTO #: _____ of _____

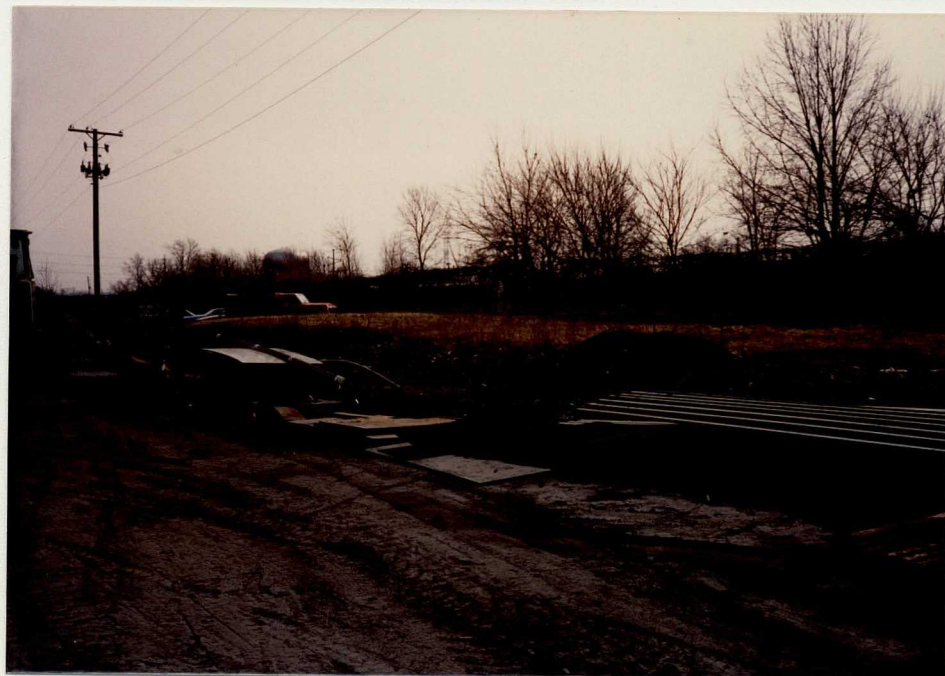
(14)

PROJECT/CASE NO: Refined Metals
SUBJECT: maintenance area
LOCATION: South side
CITY: _____ COUNTY: _____ STATE: _____
DATE: _____ TIME: _____
WEATHER: (SUN) (HAZE) (CLOUDY) (RAIN) (SNOW)
PHOTOGRAPHER (Sig.) _____
WITNESS: _____
CAMERA: _____
FILM TYPE: _____ ASA: _____ T.I.: _____ f: _____
NEGATIVE LOCATION: _____ FILE #: _____
PROCESSED BY: _____
PHOTO #: _____ of _____

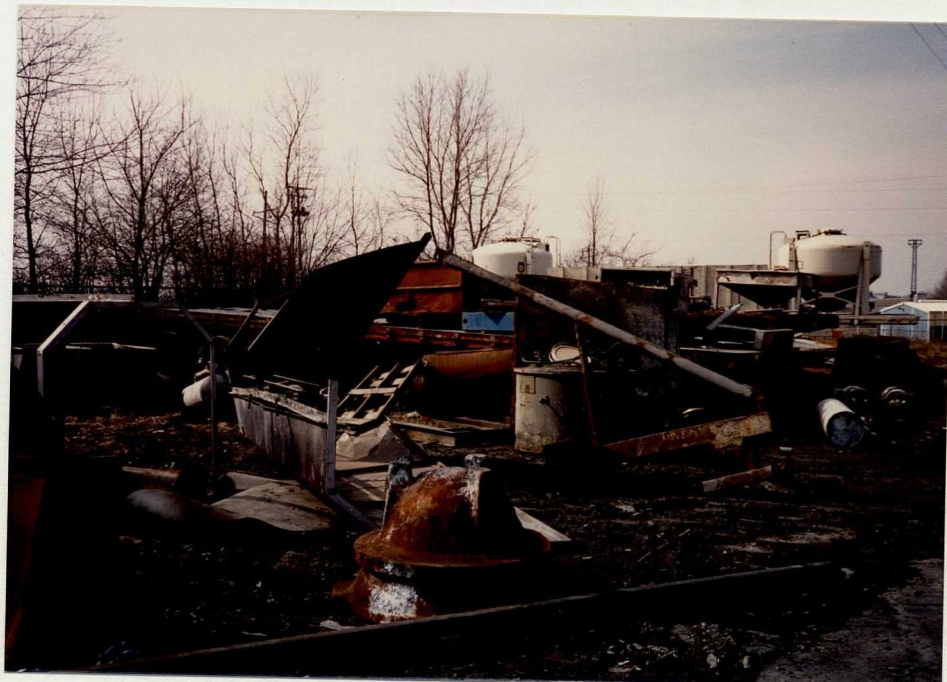
(15)

PROJECT/CASE NO: Refined Metals
SUBJECT: scrap pile
LOCATION: South side
CITY: _____ COUNTY: _____ STATE: _____
DATE: _____ TIME: _____
WEATHER: (SUN) (HAZE) (CLOUDY) (RAIN) (SNOW)
PHOTOGRAPHER (Sig.) _____
WITNESS: _____
CAMERA: _____
FILM TYPE: _____ ASA: _____ T.I.: _____ f: _____
NEGATIVE LOCATION: _____ FILE #: _____
PROCESSED BY: _____
PHOTO #: _____ of _____

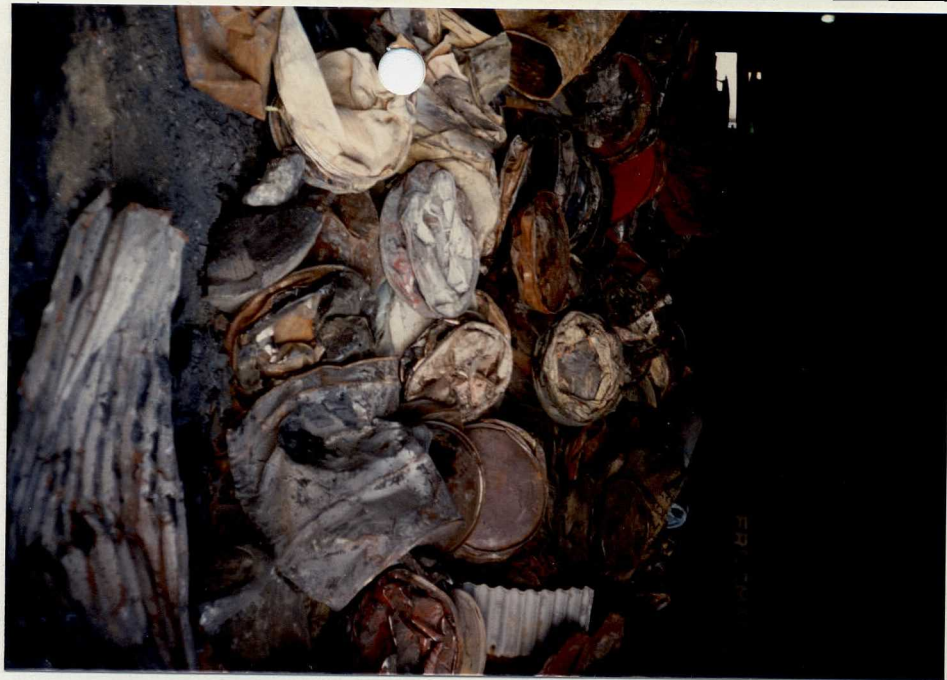
16

PROJECT/CASE NO: Refined Metals
SUBJECT: Wastepile / cans, drums
LOCATION: Materials Bldg.
CITY: _____ COUNTY: _____ STATE: _____
DATE: 2/24/87 TIME: _____
WEATHER: (SUN) (HAZE) (CLOUDY) (RAIN) (SNOW)
PHOTOGRAPHER (Sig.) - Judy Klemen
WITNESS: Dave Kaeppner
CAMERA: Ricoh
FILM TYPE: 35mm ASA 100 T11 f. _____
NEGATIVE LOCATION: _____ FILE #: _____
PROCESSED BY: _____
PHOTO #: _____ of _____

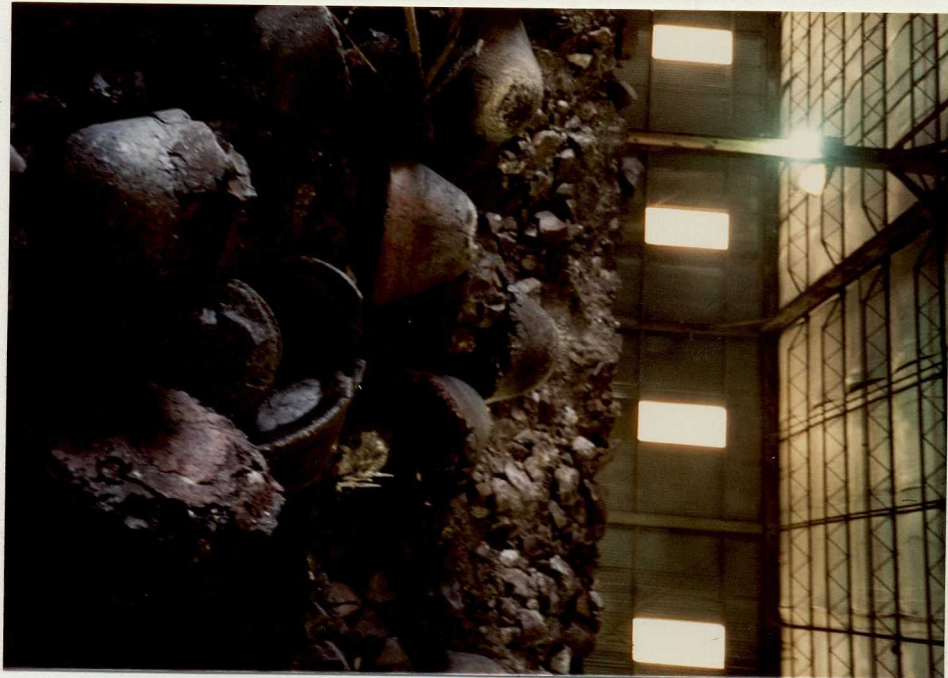
17

PROJECT/CASE NO: Refined Metals
SUBJECT: Wastepile / slag from furnace
LOCATION: Materials Building
CITY: _____ COUNTY: _____ STATE: _____
DATE: 2/24/87 TIME: _____
WEATHER: (SUN) (HAZE) (CLOUDY) (RAIN) (SNOW)
PHOTOGRAPHER (Sig.) - Judy Klemen
WITNESS: Dave Kaeppner
CAMERA: Ricoh
FILM TYPE: 35mm ASA 100 T11 f. _____
NEGATIVE LOCATION: _____ FILE #: _____
PROCESSED BY: _____
PHOTO #: _____ of _____

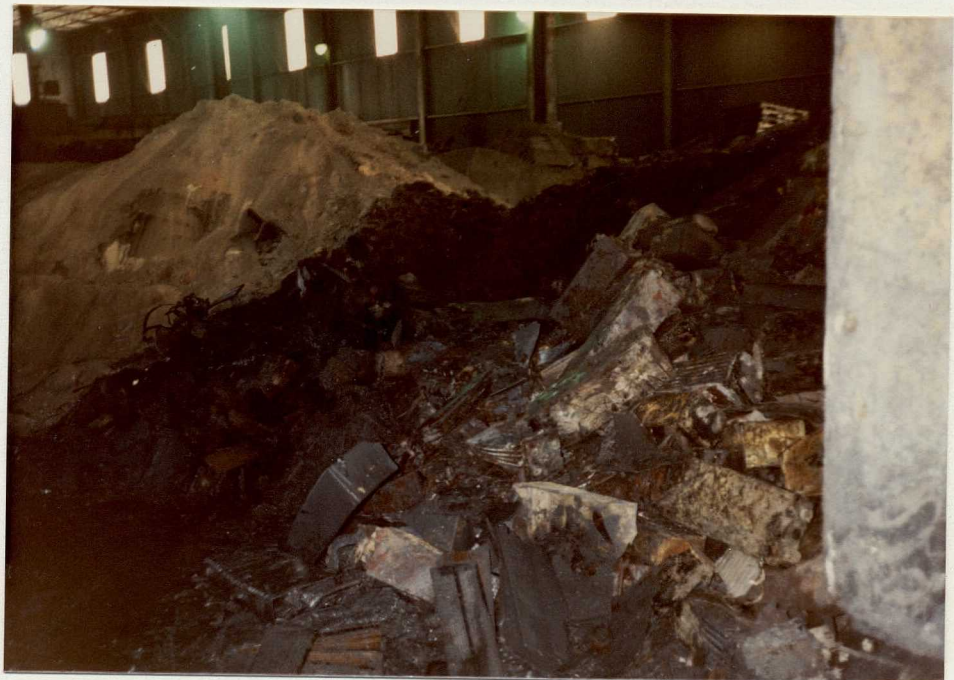
18

PROJECT/CASE NO: Refined Metals
SUBJECT: Wastepile
LOCATION: Materials Building
CITY: _____ COUNTY: _____ STATE: _____
DATE: _____ TIME: _____
WEATHER: (SUN) (HAZE) (CLOUDY) (RAIN) (SNOW)
PHOTOGRAPHER (Sig.) - Judy Klemen
WITNESS: Dave Kaeppner
CAMERA: _____
FILM TYPE: _____ ASA _____ T11 _____ f. _____
NEGATIVE LOCATION: _____ FILE #: _____
PROCESSED BY: _____
PHOTO #: _____ of _____

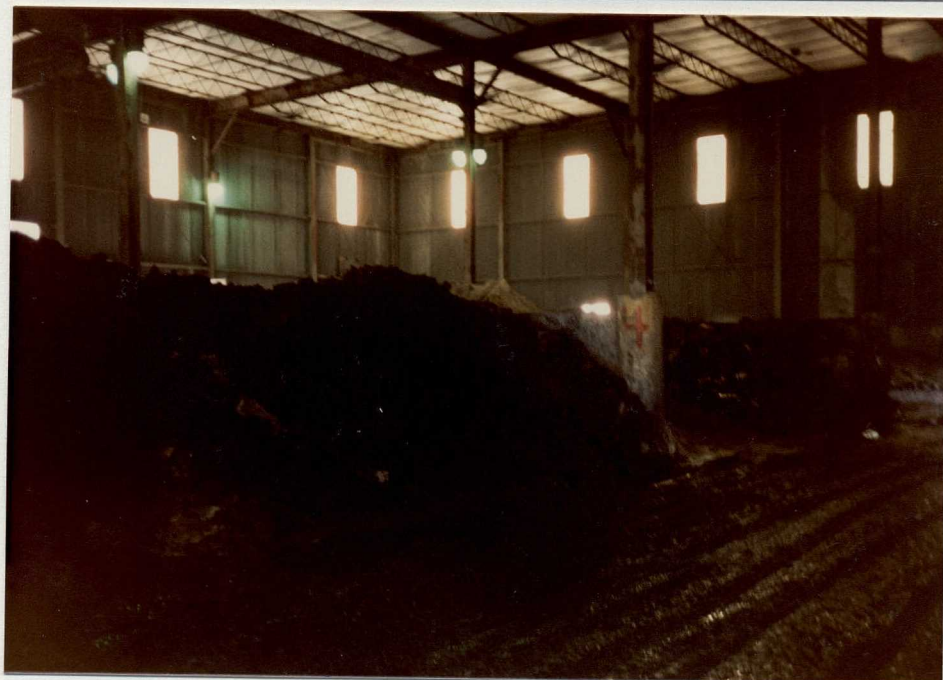
PROJECT/CASE NO: Refined Metals
SUBJECT waste pile, slurry on floor
LOCATION: Materials Building
CITY: _____ COUNTY: _____ STATE: _____
DATE _____ TIME _____
WEATHER: (SUN) (HAZE) (CLOUDY) (RAIN) (SNOW)
PHOTOGRAPHER (Sg.) Judy Klemen
WITNESS Dave Koepfer
CAMERA: Ricoh
FILM TYPE 35mm ASA 100 T.1/ _____ F. _____
NEGATIVE LOCATION: _____ FILE #: _____
PROCESSED BY: _____
PHOTO #: _____ of _____

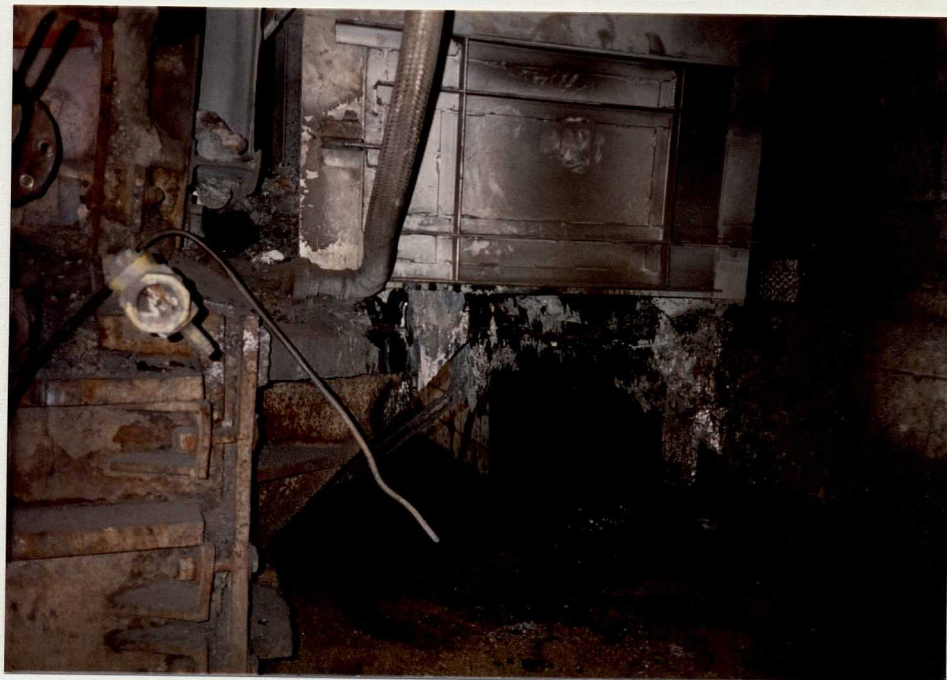
B. Unit Description: Blast Furnace is used to
burn waste material containing lead. Lead
is melted down and collected. Slag + flue
dust from this process are recycled.
No other information is available on this unit

PROJECT/CASE NO: Refined Metals
SUBJECT Blast Furnace
LOCATION: _____
CITY: _____ COUNTY: _____ STATE: _____
DATE _____ TIME _____
WEATHER: (SUN) (HAZE) (CLOUDY) (RAIN) (SNOW)
PHOTOGRAPHER (Sg.) Judy Klemen
WITNESS Dave Koepfer
CAMERA: Ricoh
FILM TYPE 35mm ASA 100 T.1/ _____ F. _____
NEGATIVE LOCATION: _____ FILE #: _____
PROCESSED BY: _____
PHOTO #: _____ of _____

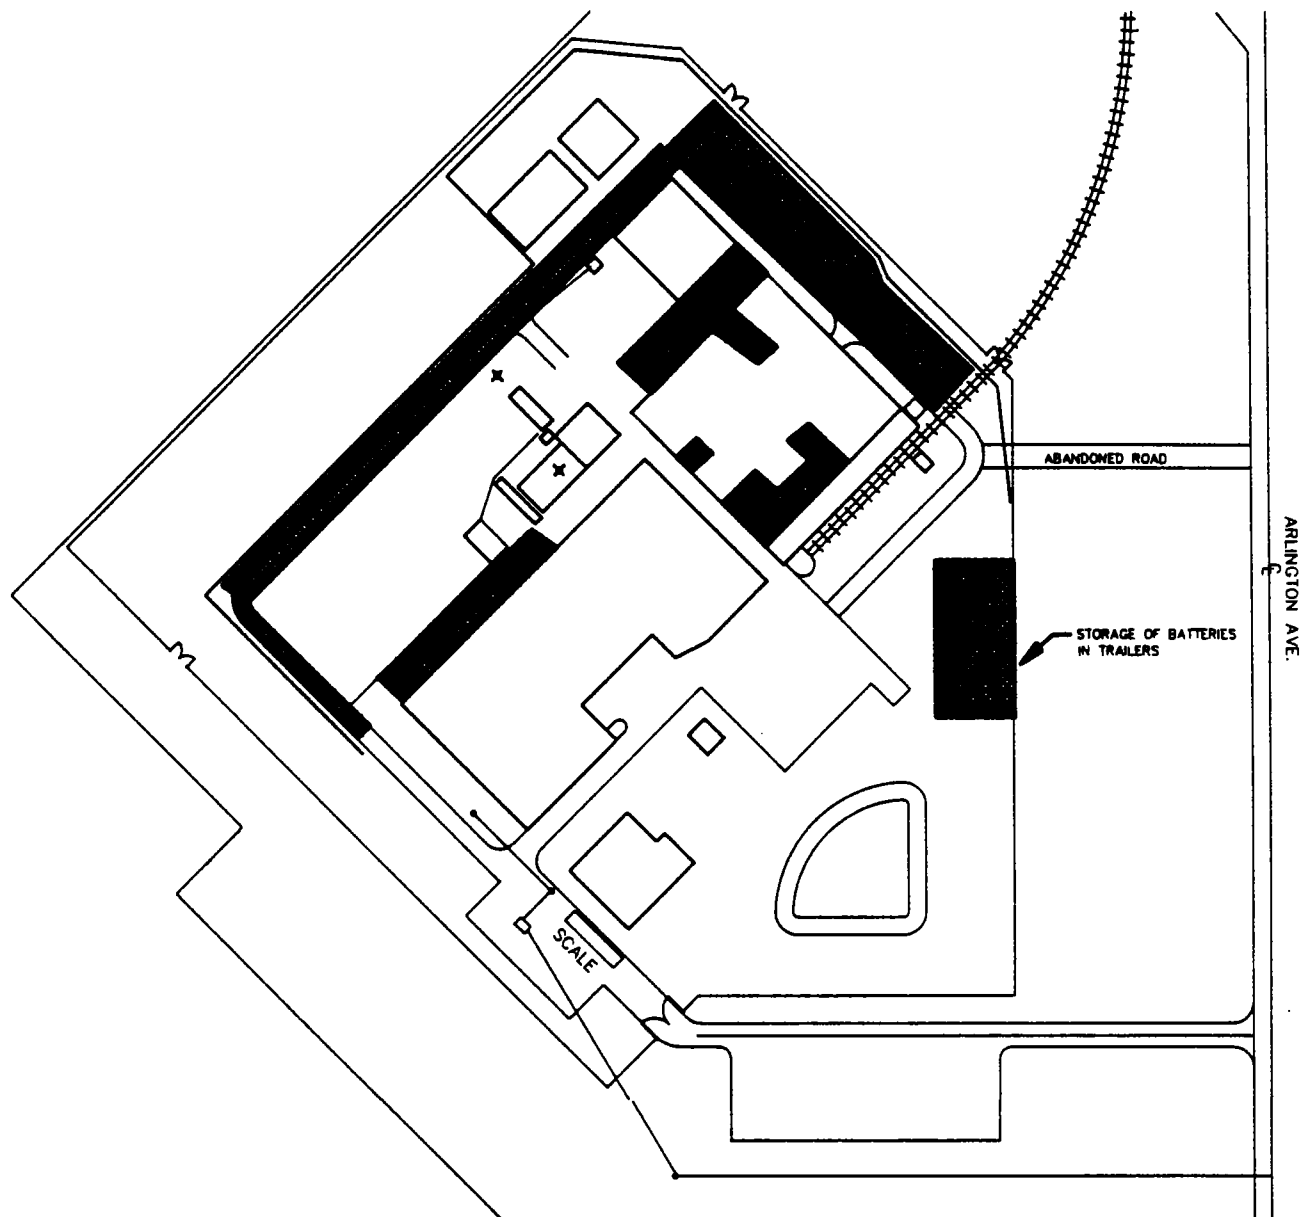
FIGURE
3-1

CONTAINER
STORAGE AREA
